ANALYSIS OF SPACECRAFT ON-ORBIT ANOMALIES AND LIFETIMES

PRC R-3579
10 FEBRUARY 1983

Prepared for
National Aeronautics and Space Administration
Goddard Space Flight Center

Prepared by
Charles Bloomquist
Winifred Graham

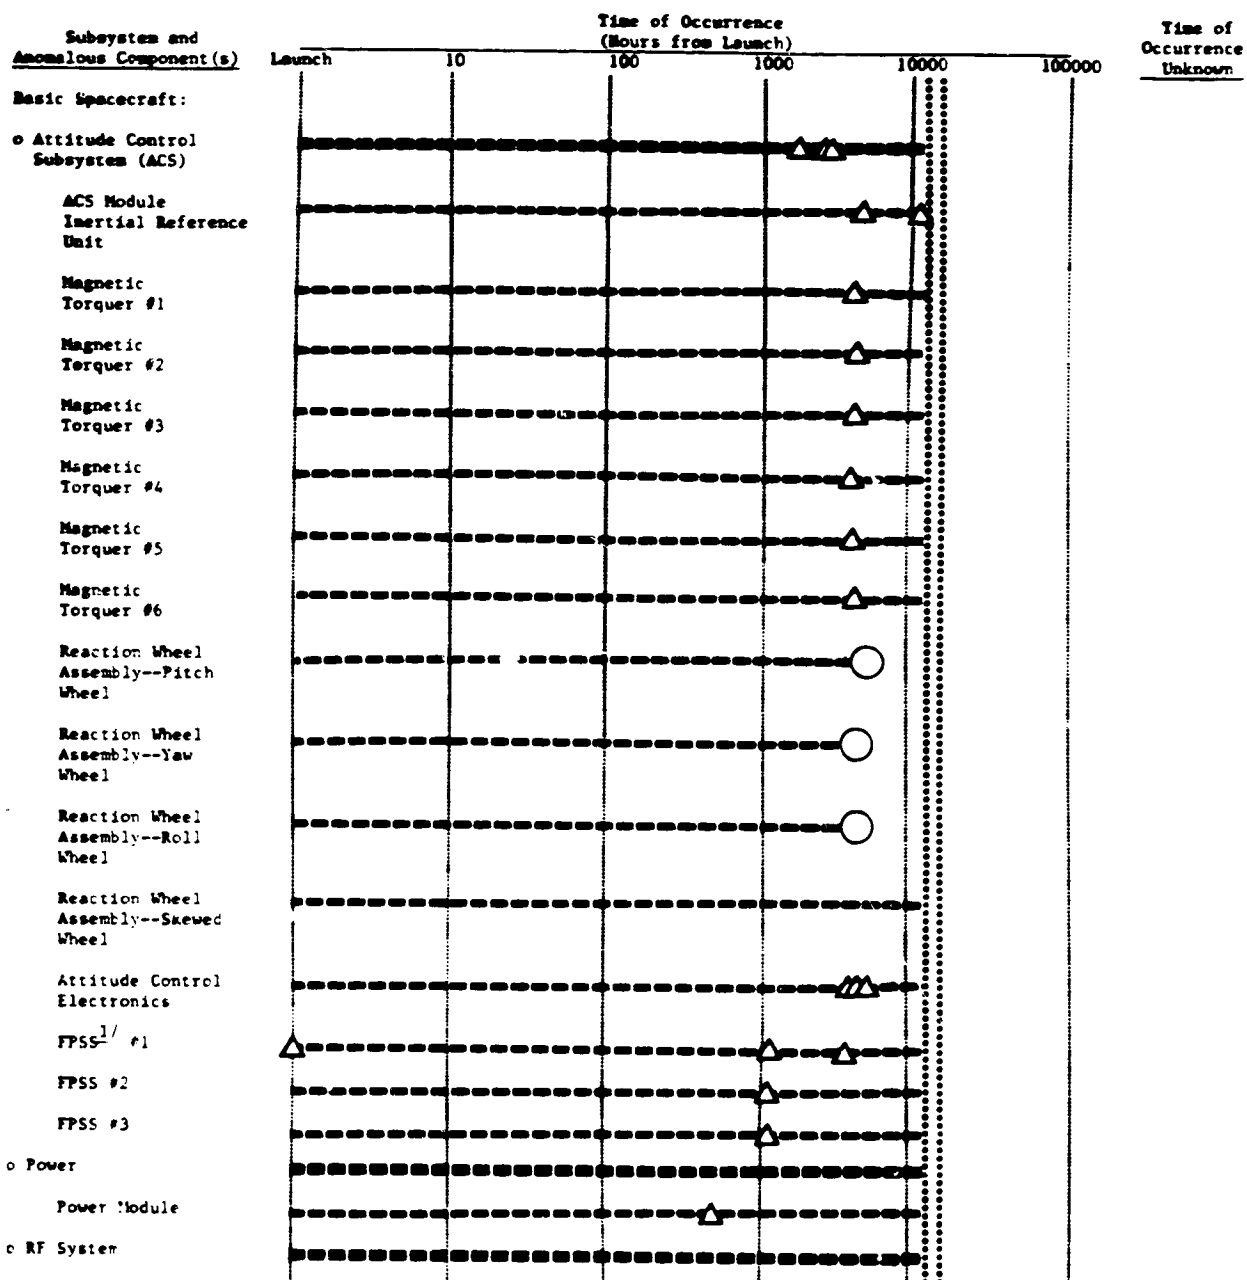
End of Data:
12,768 hours;
SHM is no
longer
operating.

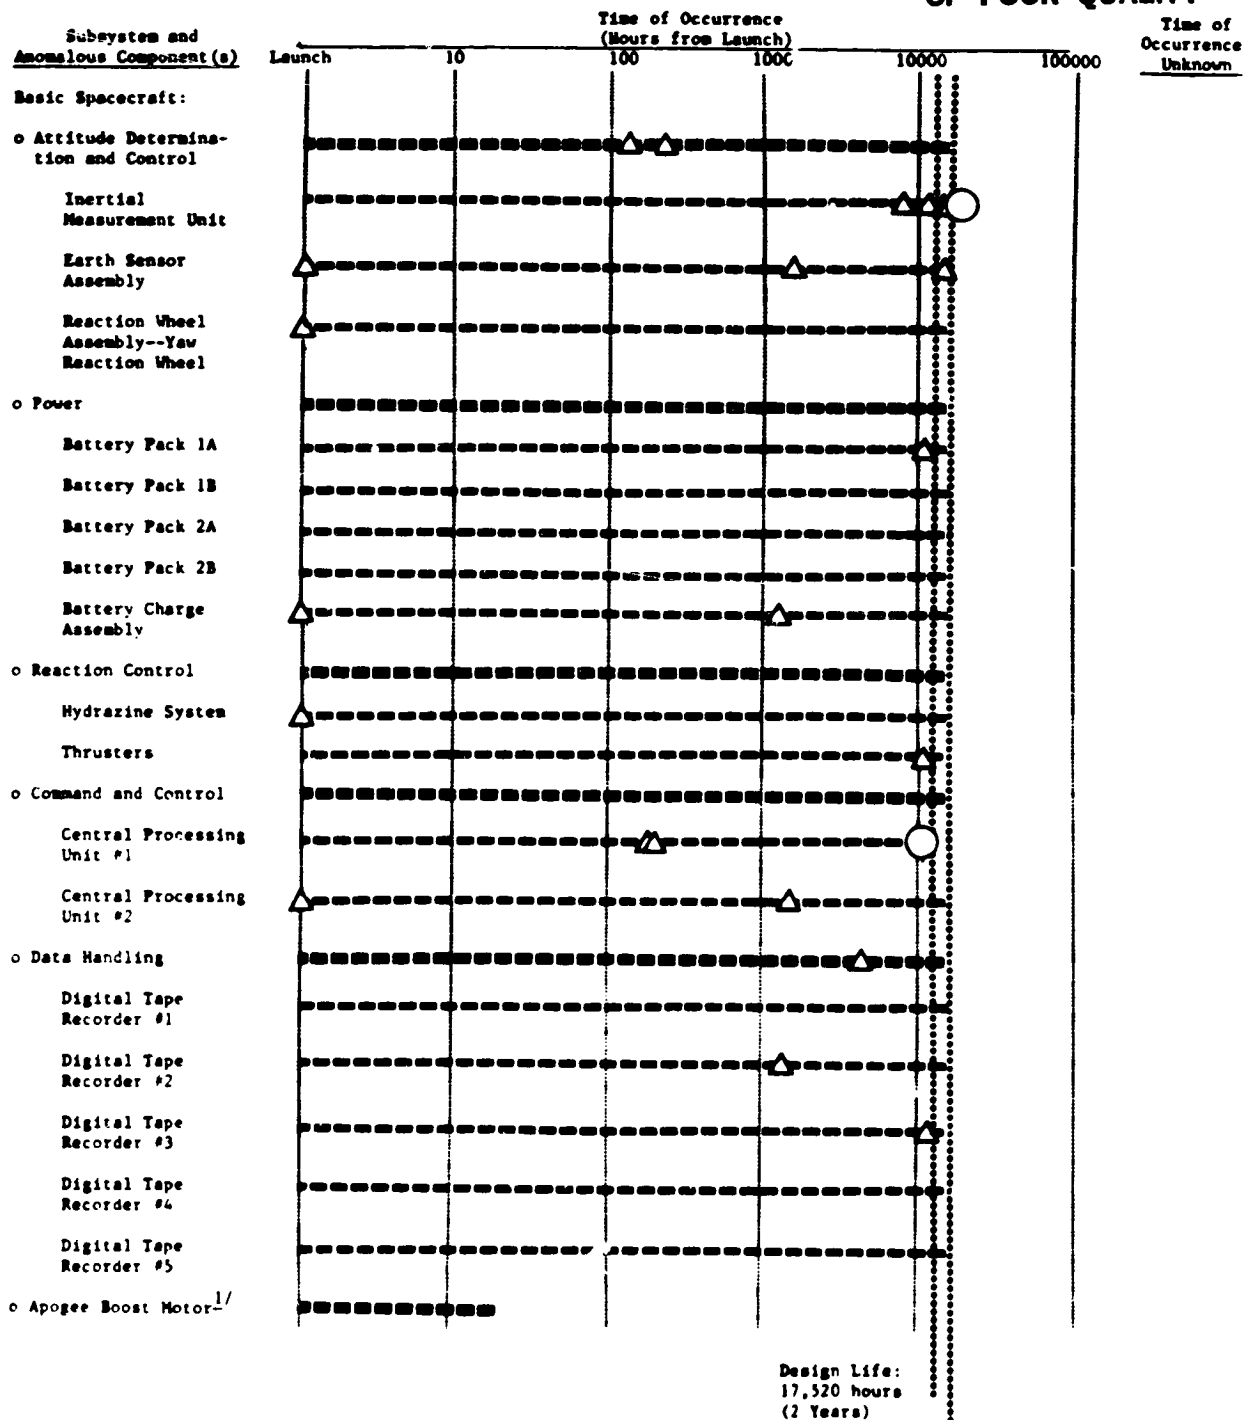
End of Data:
20,800 hours;
TIROS-N mission
terminated due to
inertial measurement
unit power failure.

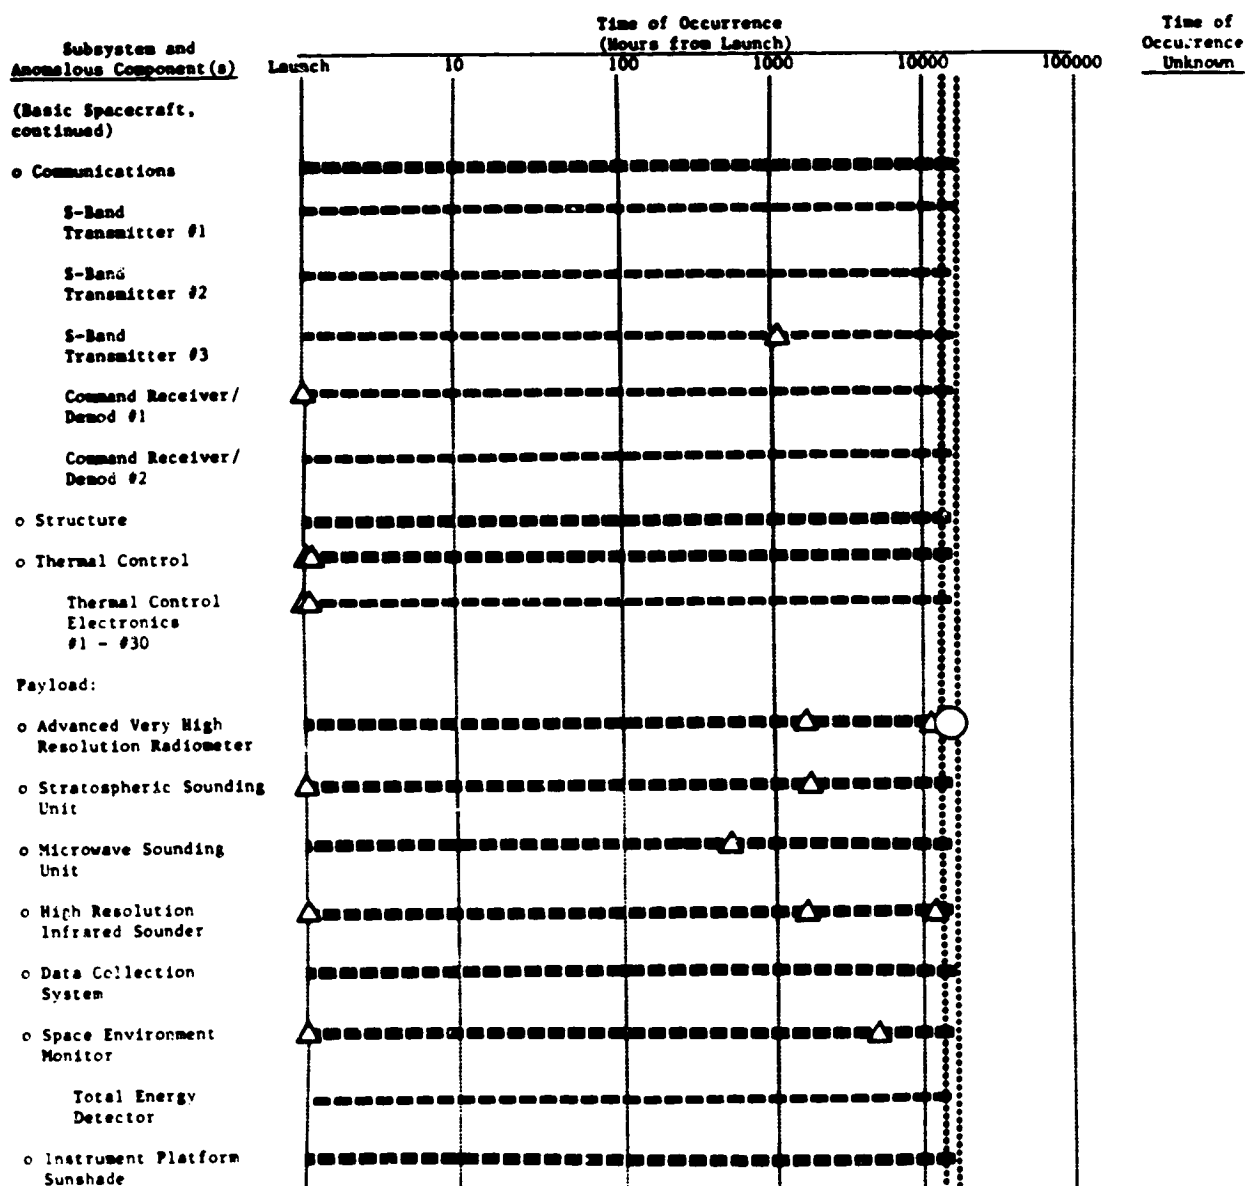
PERFORMANCE SUMMARY FOR TIROS-N
(Continued)

End of Data:
20,800 hours:
TIROS-N mission
terminated due to
inertial measurement
unit power failure.

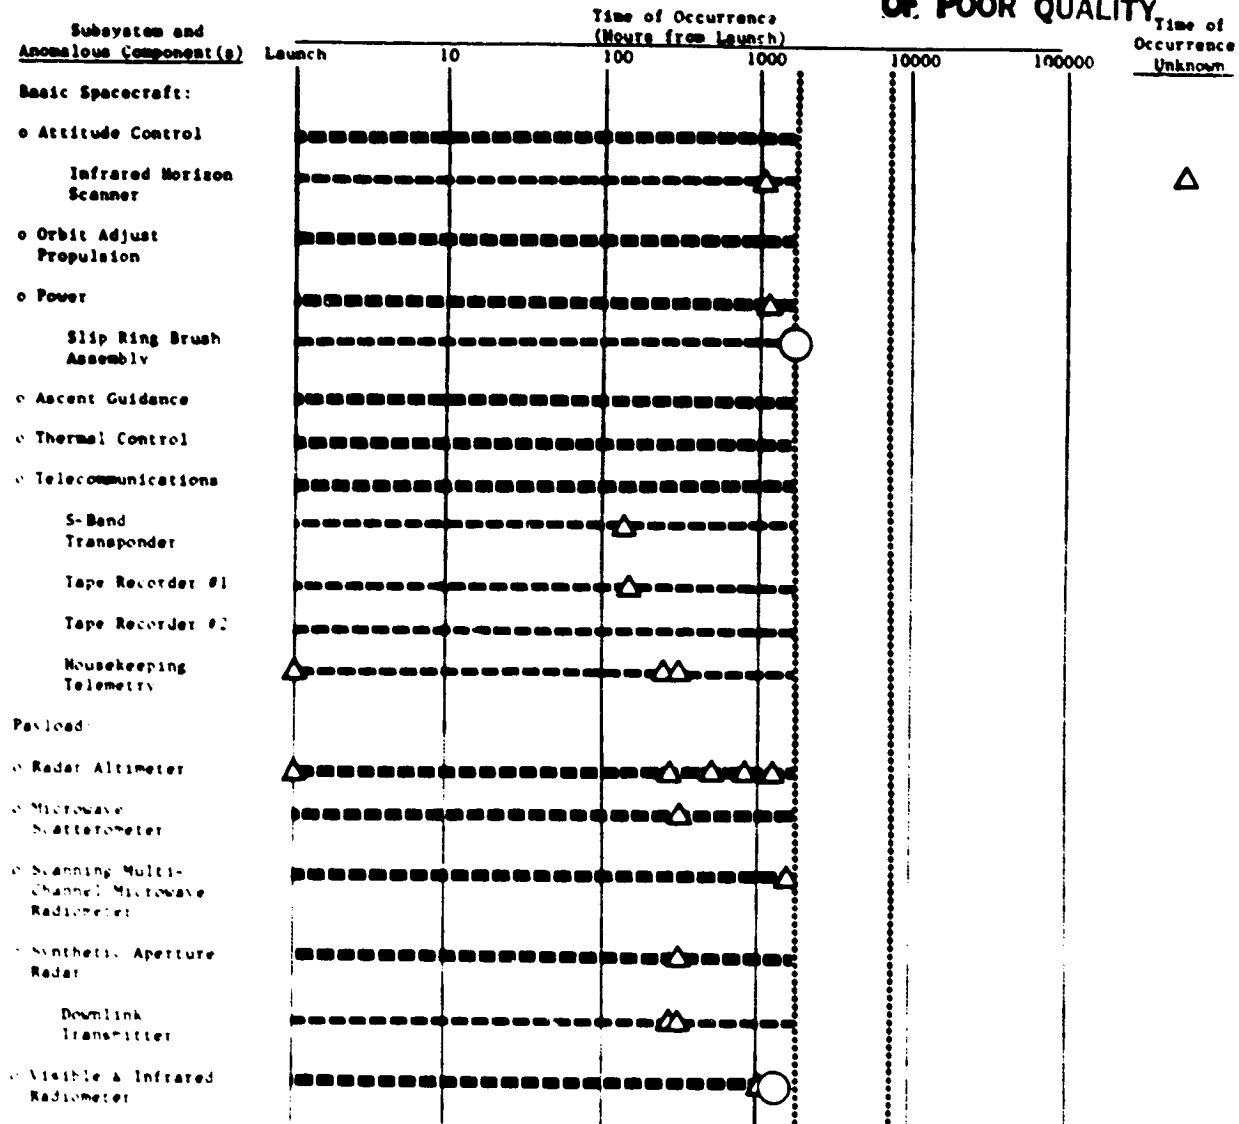
End of Data:
2,520 hours;
SEASAT mission
failed.
